GRADUAL STRENGTHENING OF EXISTING MASONRY HOUSES WITH FERROCEMENT BANDAGING IN INDONESIA FOR EDUCATING THE COMMON PEOPLE TO BE SELF-RELIANT AND SELF-SUPPORTING

FEBRIN ANAS ISMAIL^{1*}, TEDDY BOEN², RENDY THAMRIN¹

¹Civil Engineering Department, Faculty of Engineering, Universitas Andalas. Padang West Sumatra, Indonesia

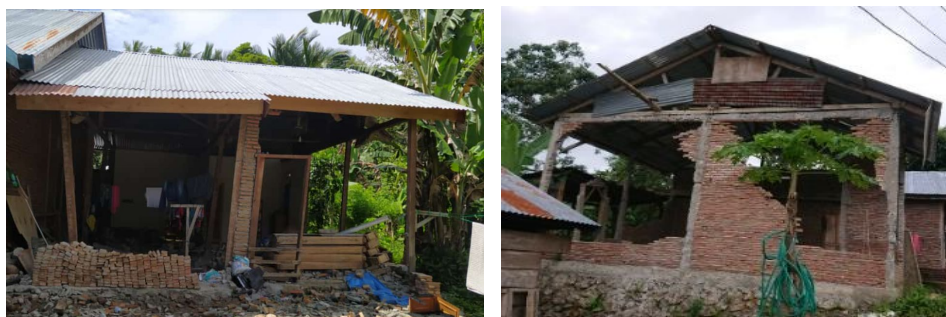
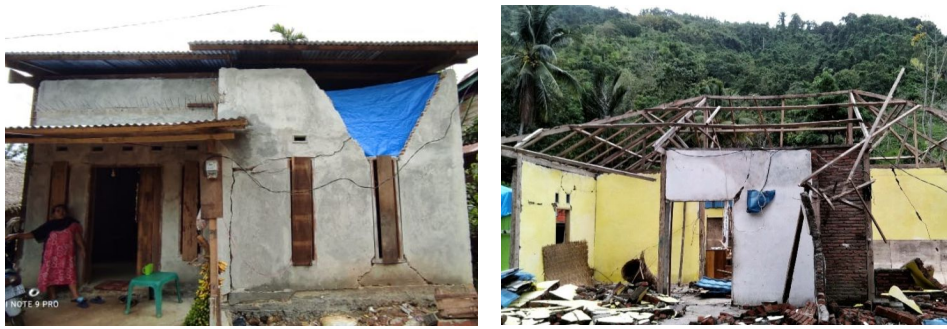
Figure. 1 Examples of poorly built houses from the West Sulawesi Earthquake in January 15, 2021

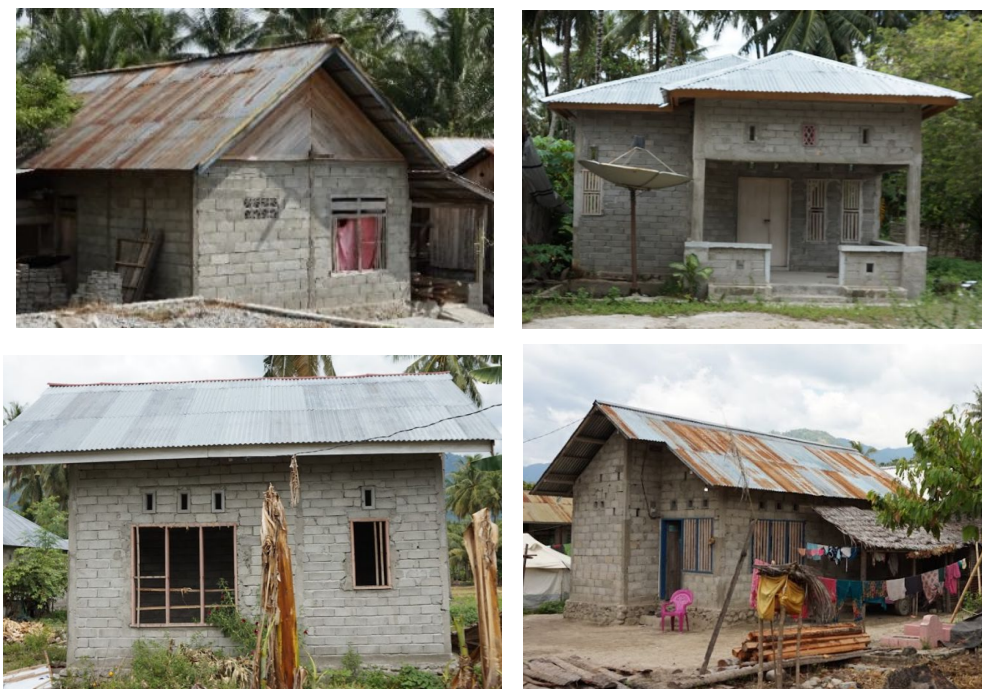
Figure. 2 Examples of poorly built houses from the Palu (Central Sulawesi) Earthquake in September 28, 2018

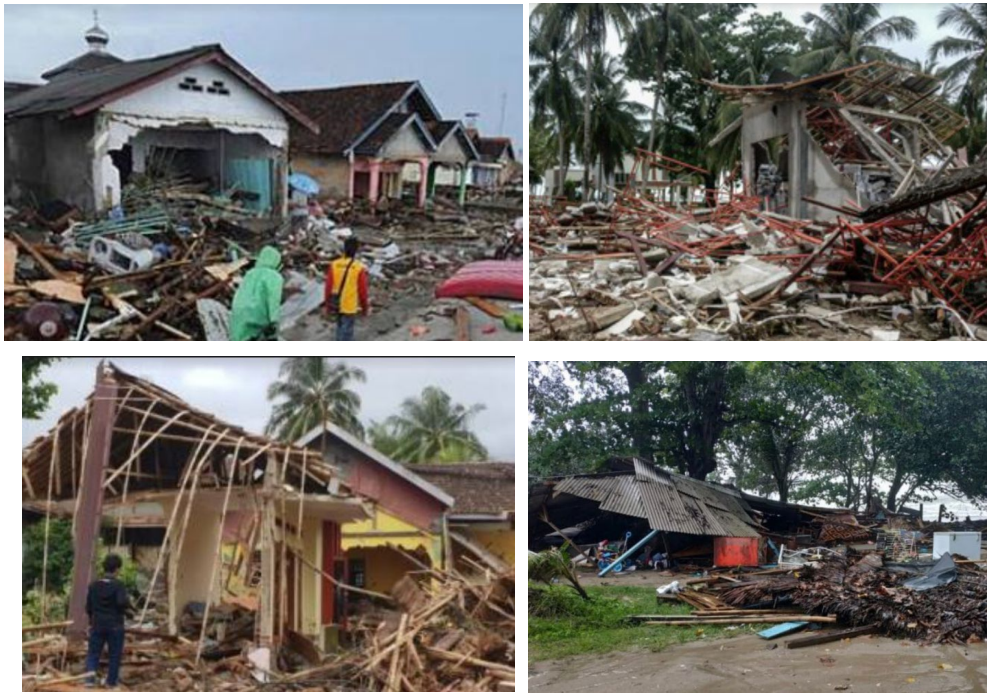
Figure. 3 Examples of poorly built houses from the Selat Sunda Earthquake and Tsunami in December 22, 2018

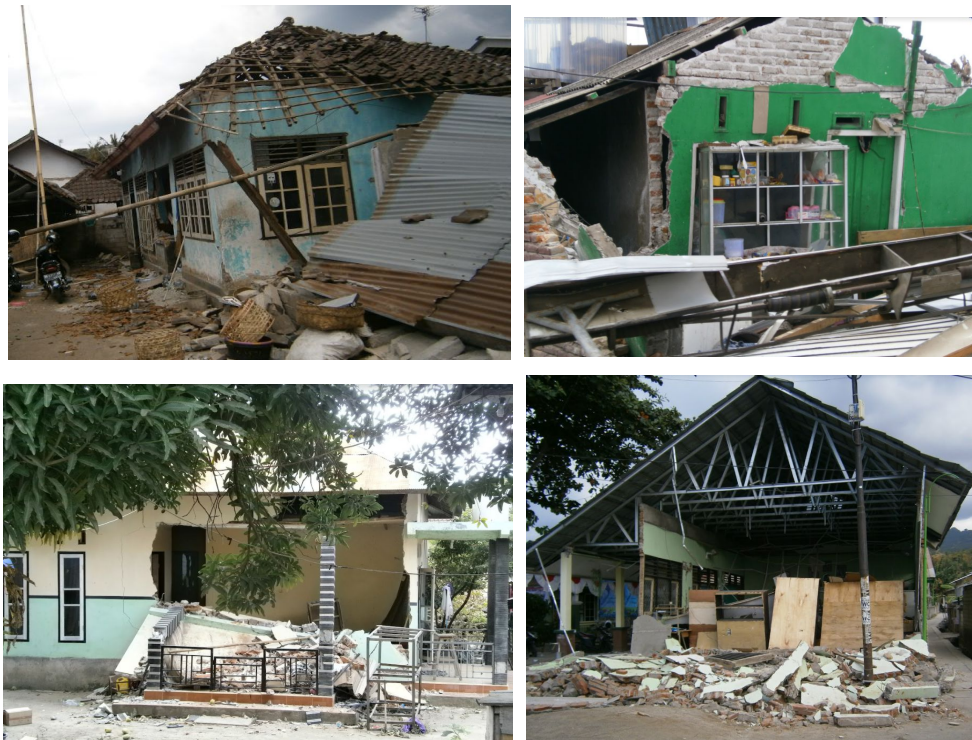
Figure. 4 Examples of poorly built houses from the Lombok Earthquake in July 29, 2018

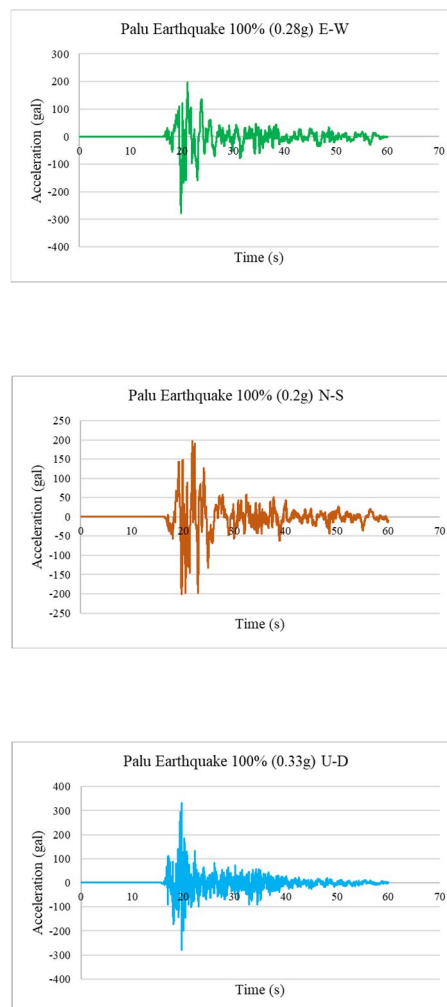
Figure. 8 Palu (Central Sulawesi) earthquake records (Masyhur Irsyam, 2015)

The earthquake records used in the analysis are the September 28, 2018 Palu (Central Sulawesi) earthquake (0.33g), and the September 30, 2009 Padang (West Sumatra) earthquake (0.3g) (Prof. Dr. Ir. Masyhur Irsyam, M.S.E. and Andhika Sahadewa, S.T., M.S.E., Ph.D., 2018; Rusnardi, 2009). The Palu earthquake record represent a single pulse type earthquake dominant in U-D direction (see **Figure. 8**). Meanwhile, the Padang earthquake record represent a multiple pulse type earthquake dominant in N-S direction (see **Figure. 9**). The analysis of the model for both earthquake records is conducted by running earthquake loads in 3 directions simultaneously, namely the X, Y, and Z directions of the building as can be seen in **Figure. 6**. The X direction of the building is given an E-W direction of earthquake load, the Y direction of the building is given an N-S direction of earthquake load, and the Z direction of the building is given a U-D direction of earthquake load.

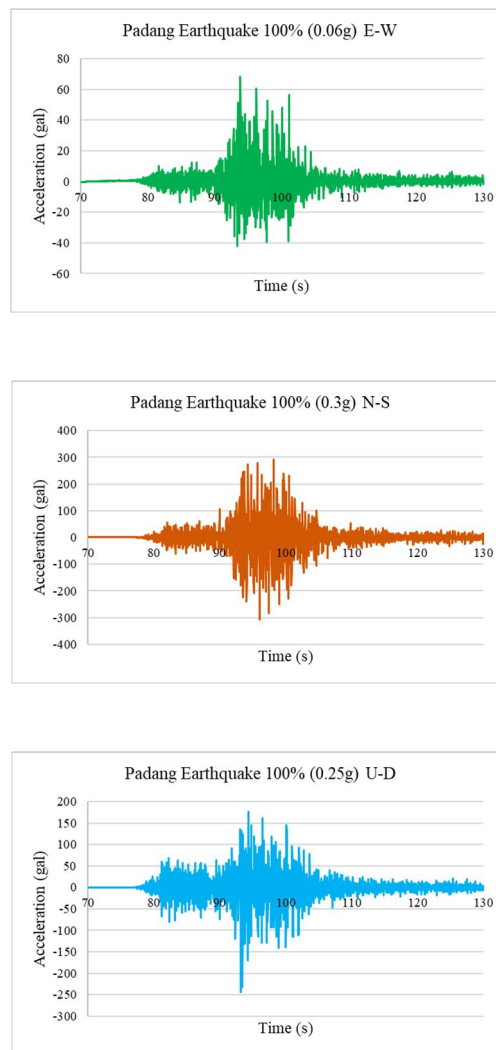
Figure. 9 Padang (West Sumatra) earthquake records (Rusnardi, 2009)

- The damaged walls indicated in blue color is the result of the large out-of-plane load caused by the N-S direction earthquake. Since Padang earthquake records in N-S direction is larger than E-W direction (see **Figure. 9**), the damaged masonry walls in **Figure. 13** are perpendicular in N-S direction.
